Mode of Slope Failure of Moderately to Completely Weathered Metasedimentary Rock at Bukit Panji, Chendering, Kuala Terengganu

Abstract

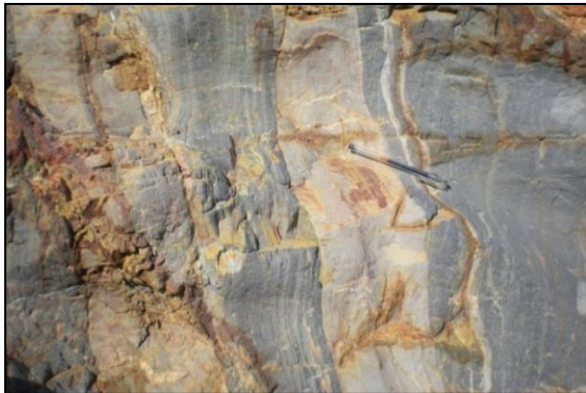
Geology of the site is essentially consisting of metamorphosed sedimentary rocks, which can be classified as interbedded metaquartzite, phyllite with minor intercalation of slate (Figure 2). The rocks are well foliated and are heavily jointed and in places, sheared. The metaquartzite is generally fine to medium-grained, and is generally light coloured compared to phyllite and slate. Phyllite is generally fine-grained and the weathered surface is generally light yellowish to reddish brown, but light grey on freshly cut surface. Slate is very fine grained, very finely laminated and is commonly black to dark grey.

Figure 2: Metamorphosed sedimentary rocks, which can be classified as interbedded metaquartzite, phyllite with minor intercalation of slate.

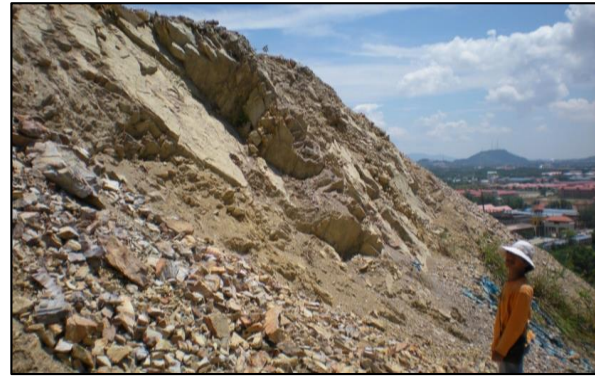
In the lower part of the slope, the rocks are moderately weathered. As moving up higher to the upper slope, the rocks gradually changed into highly weathered rocks. The rocks are well foliated and very heavily jointed. The joint spacing varies from a few cm to up to tens of cm. This is evident from the loose individual rock blocks within the failure debris, which are highly variables from as small as a few cm to up to 0.5m across (Figure 3).

Figure 3: The slope rock mass forming a high density of plane discontinuities due to tectonic action. The rock mass is prone to disintegrate into varies size to the average size of 20cm resulting slope prone to failure.

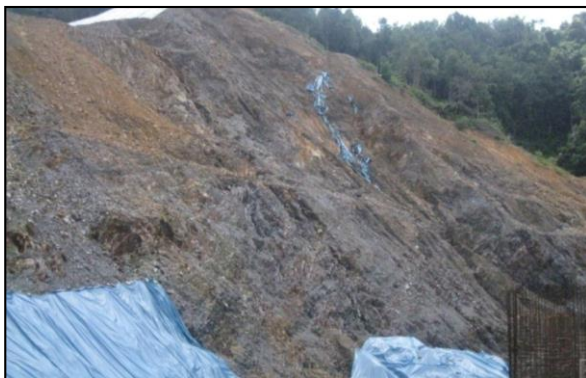
From assessment conducted on 19 slopes, there were 21 cases of slope failure were identified in the study area as shown in Table 2. A total of 17 failures occurred on cut slopes while 4 failures in embankments slope. A total of 9 failures represent 43% of slope failure is gully erosion (Figure 4). This type of failure is dominant because the slope forming material was highly to completely weathered to form 20m thick of top soil. This soil is loose and friable and easily eroded by surface water run-off, especially during heavy rain. Two major factors that control the gully erosion are erosion agent and geological factors as well as the slope angle and length of the slope face. The higher quantity and velocity of water will increase the process of erosion.

Figure 4: Gully erosion is observed because of surface water run-off. This failure becomes worse because no temporary erosion control measure was installed during construction stage.

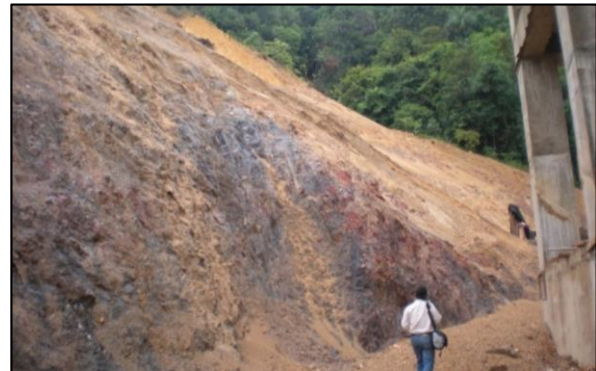
For the shallow failure, a case of failure was occurred and its size is categorized as medium (Figure 5). This failure is caused by inappropriate earthwork management where earth material is dumped along slope face without proper method. Dumping earthworks waste on the shoulder slope is an unhealthy practice of construction as this will produce a layer of loose soil on the shoulder slope. These wastes can slide down the slope, especially if there is heavy rainfall in a long period and this may contribute to the occurrence of larger slope failure (Tajul Anuar Jamaluddin, 2010a). For the wedge failure, six slope failure cases are observed and most of failures are caused by slope geometry and discontinuities orientation. Wedge failures can occur when there is an intersection between the two sets of discontinuities and the line of intersection of discontinuity planes is plunged towards the slope face (Hoek & Bray, 1981). The angle of slope face gradient, reaching 60° indirectly increase the probability of failure wedge.

Figure 5: Shallow failure occurred after heavy raining and it involved loose earth material that had dump along slope shoulder.

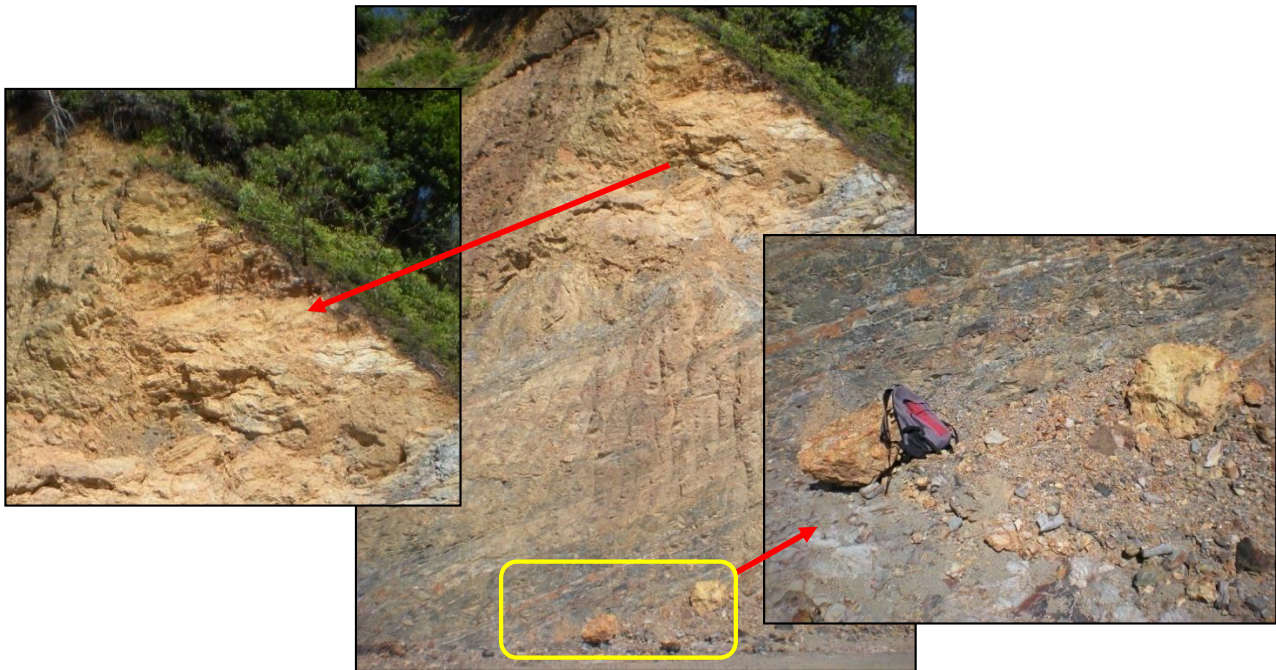
Two cases of rock falls have been recorded from this study and it's controlled by discontinuity structure on a cut slope. Rock materials involved are usually grade IV of weathered rocks. Rock fall failure usually occurred in wedge failure form, based on

intersection of two or more plane discontinuities at the scars of failure (Figure 6). Based on the assessment, there was only one case of toppling failure, which

Figure 6: Rock fall in the form of wedge failure occurred at slope G. Size of blocks that fell is measured 1m x 1m x 0.5m.
